Make a Safe Electrical Installation In Indonesia

Symposium Fisuel – Indonésie – 10 & 11 Mai 2017

Highlight on Installation Standard SNI 04-0225-2000 (PUIL 2000)

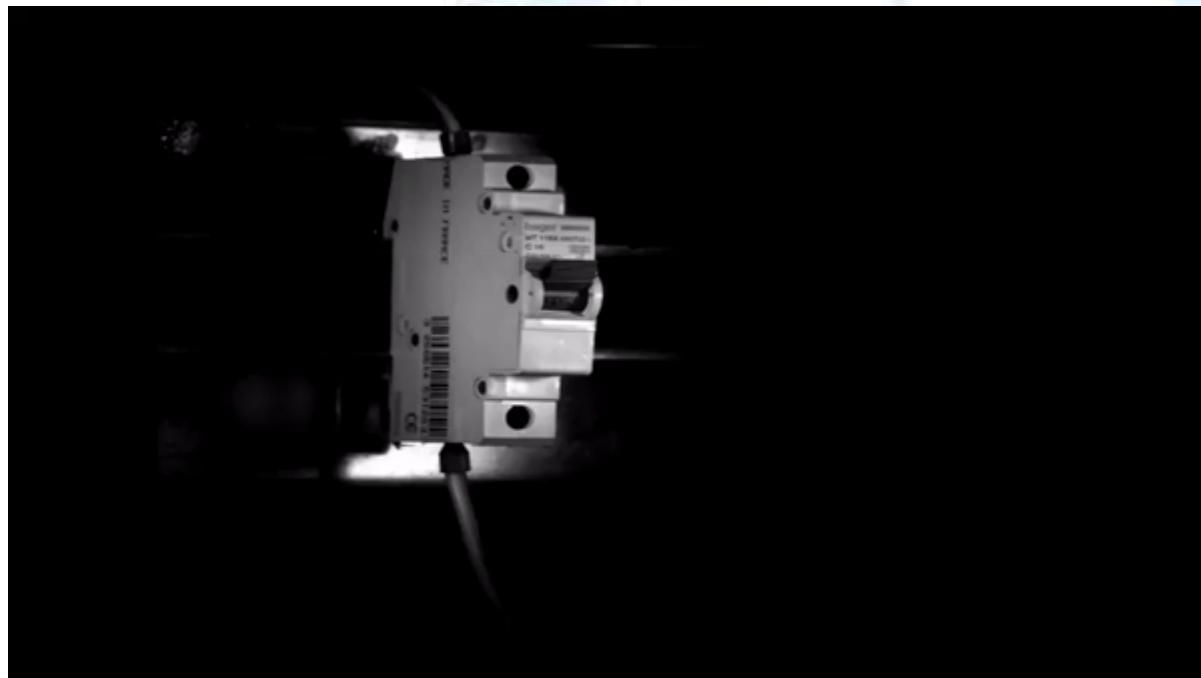
Example of using bad quality MCB

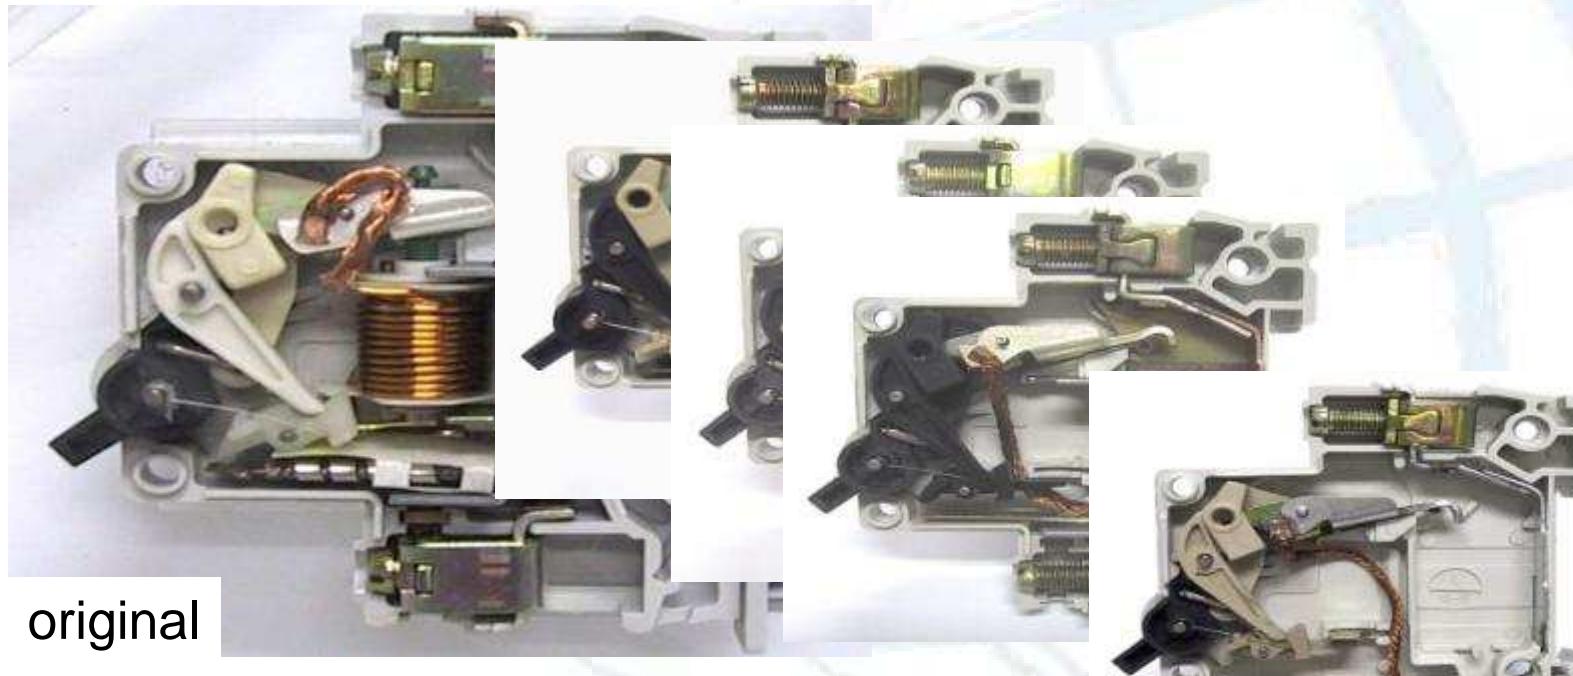
Evolution of Copycat MCB

The part that are commonly being removed is the copper coil

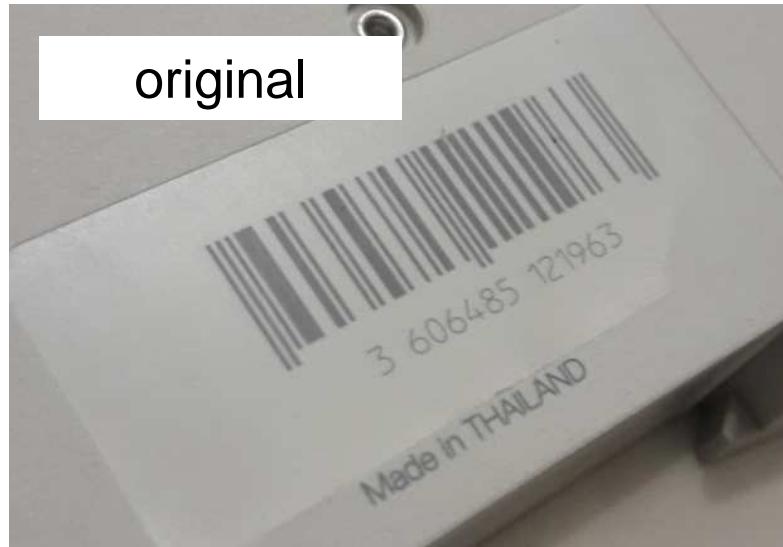
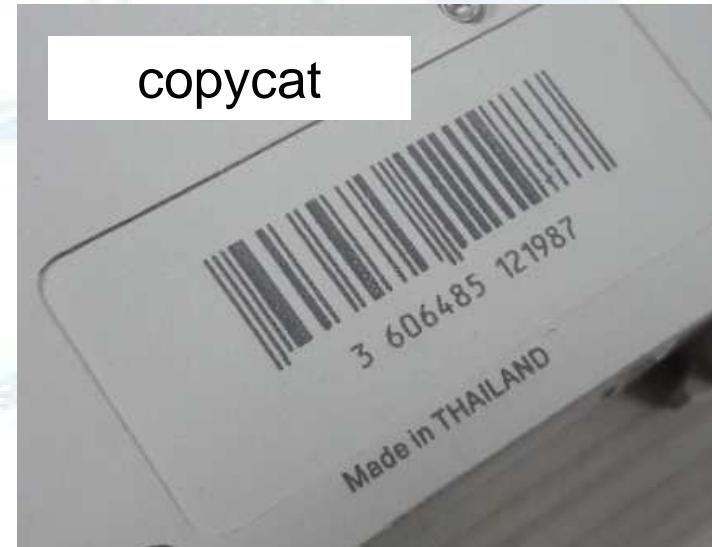
How to identify Copycat MCB ?

Original: barcode printed using laser print
(not too black, detail, good quality)

Copycat: barcode printed using carbon print
(very black, not detail, bad quality)

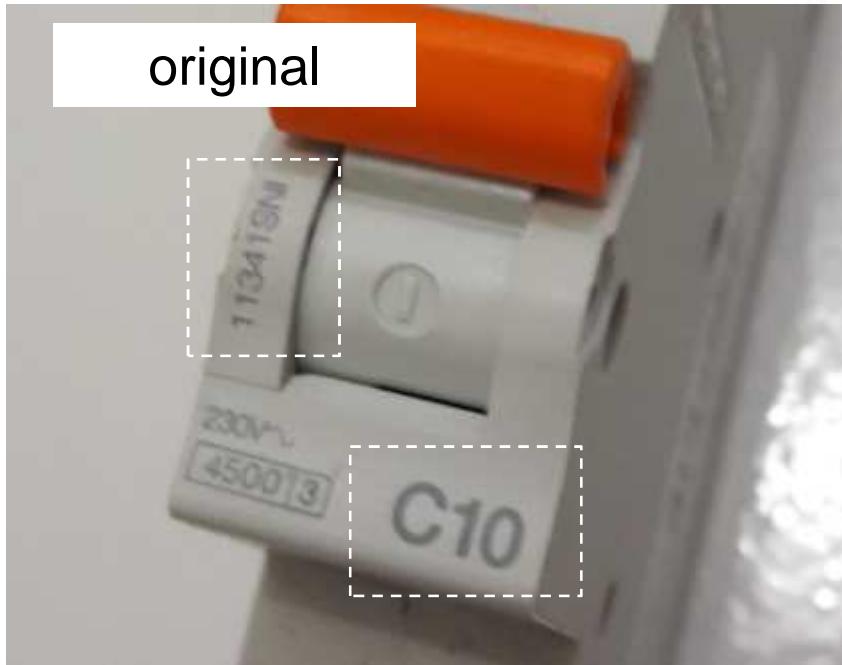
How to identify Copycat MCB ?

Pengenal (A)	Referensi
2	DOM12251SNI
4	DOM12252SNI
6	DOM11340SNI
10	DOM11341SNI
16	DOM11342SNI
20	DOM11343SNI
25	DOM11344SNI
32	DOM11345SNI
40	DOM11346SNI
50	DOM11335SNI
63	DOM11336SNI

Original MCB:
Reference number matches with
Ampere Rating
