# Current Status of PV Facilities and Vision for the Future

Kato Akihito

Kyushu Electrical Safety Inspection Association

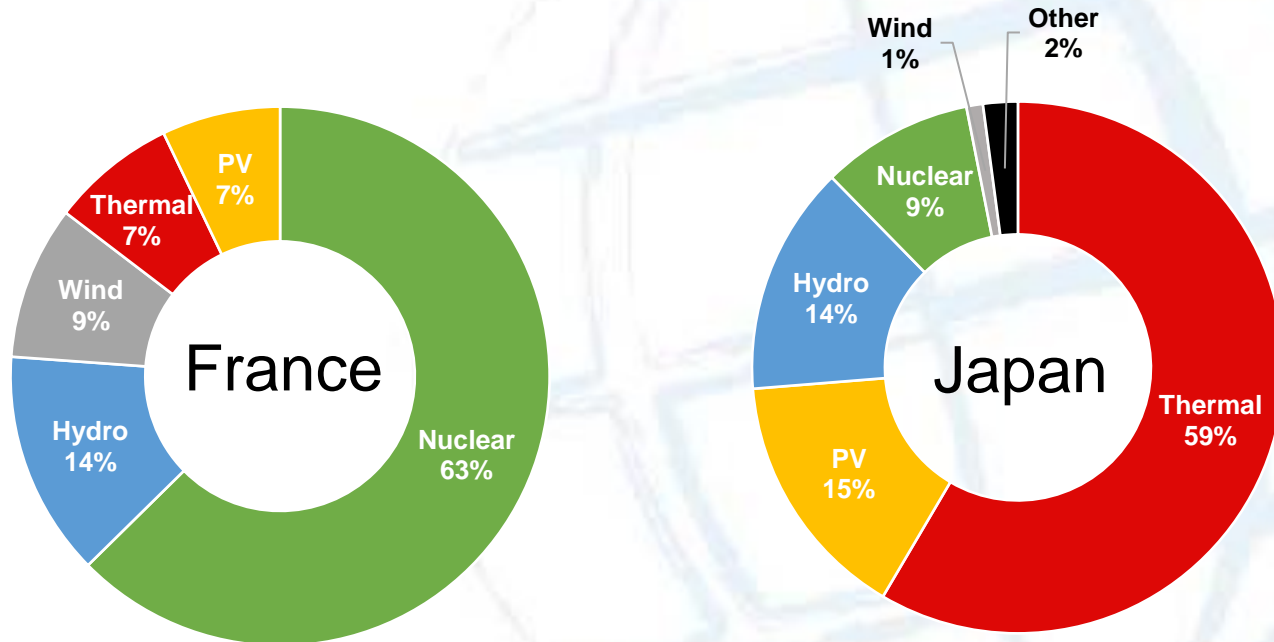
## Differences in the amounts of power generation in France and Japan

Source: Prepared based on IEA monthly electricity statistics data. Categories of power generation that make up smaller than whole number percentages are not included to improve visibility.

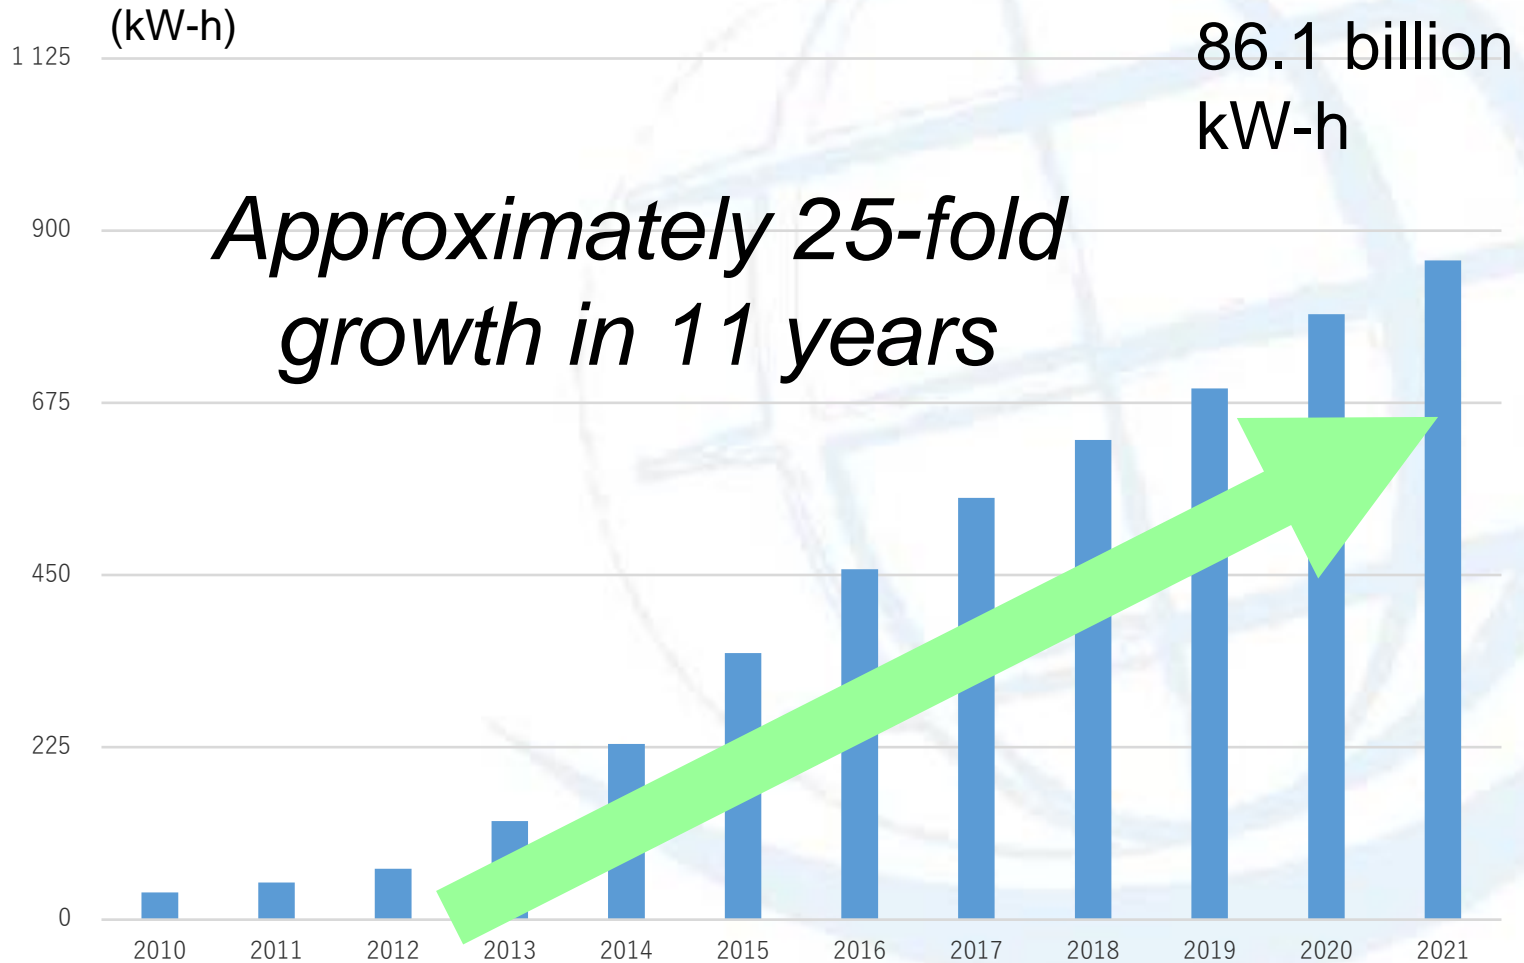
## Growing PV-generated power in Japan

3.5 billion kW-h

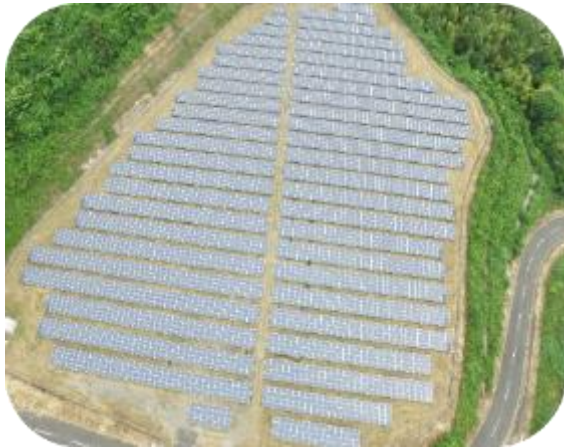
Large-scale  
ground mounted

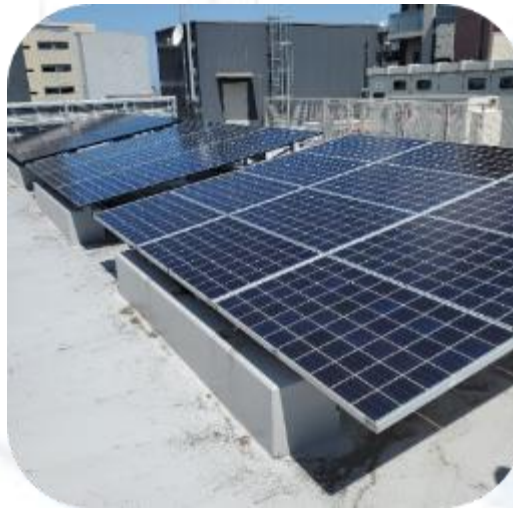
Rooftop mounted

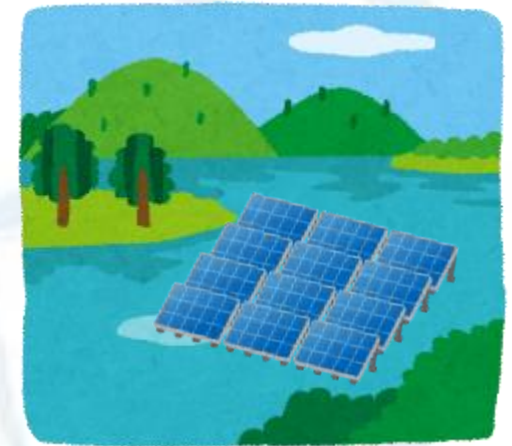
Floating

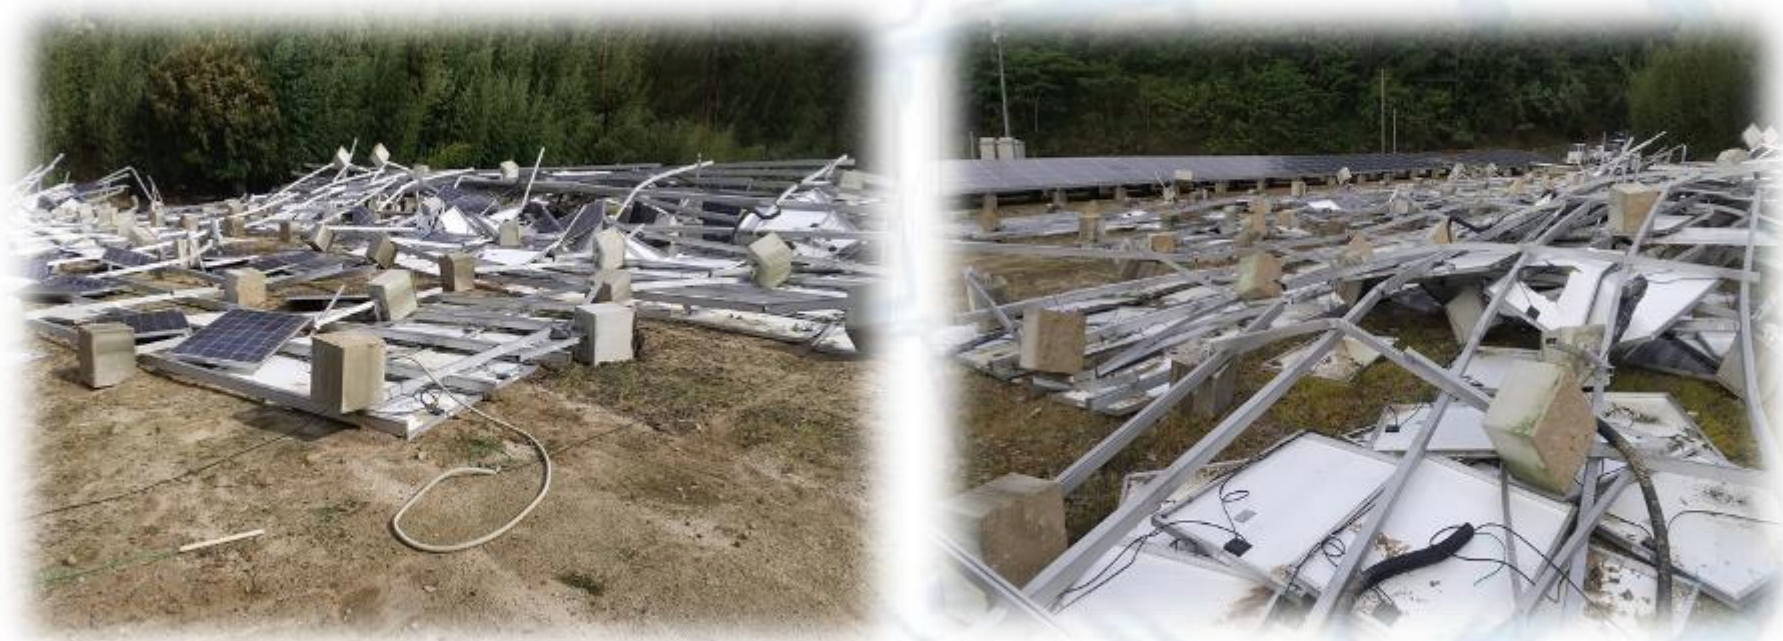
Typhoon damage

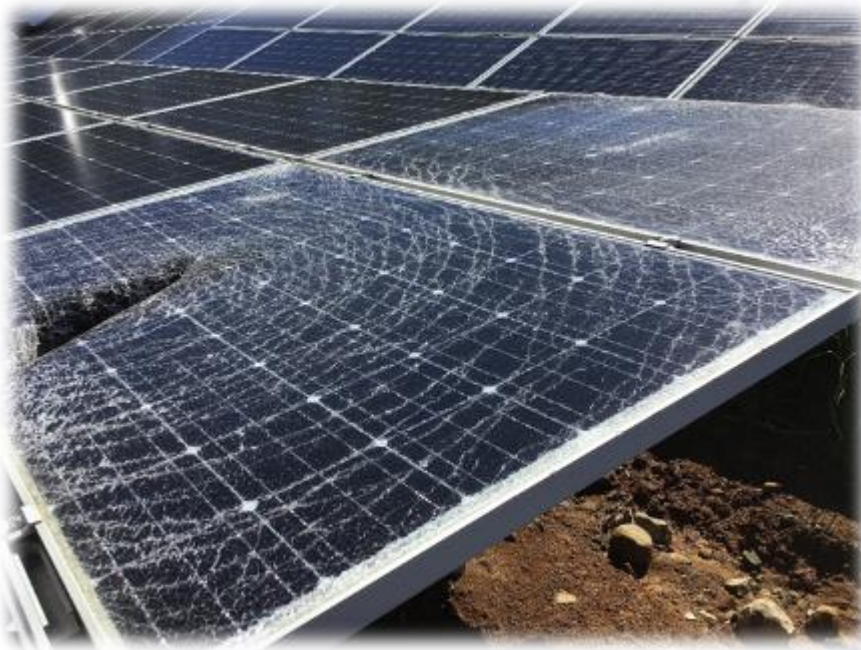
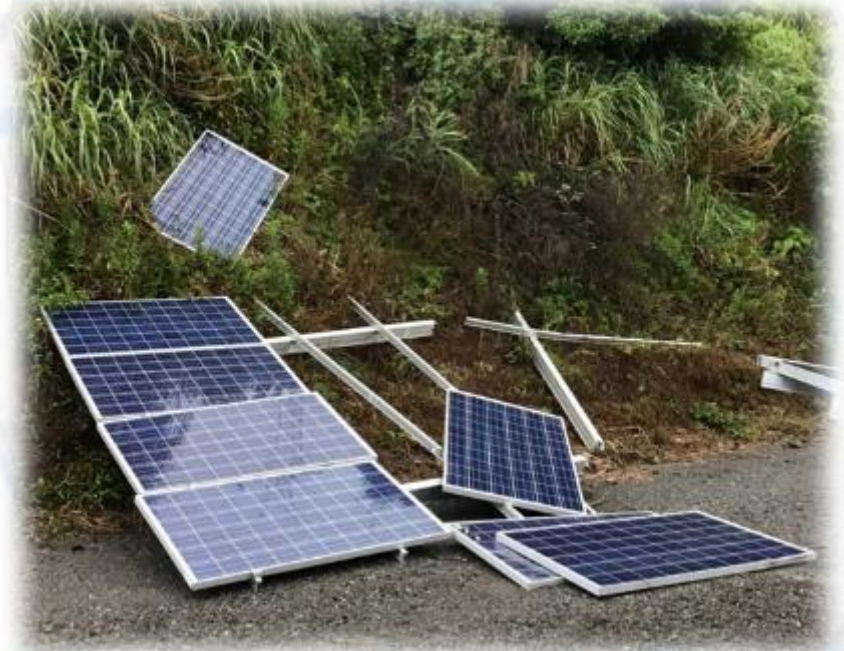
Are there any potential  
airborne debris nearby?

Are the panels securely  
fixed in place?

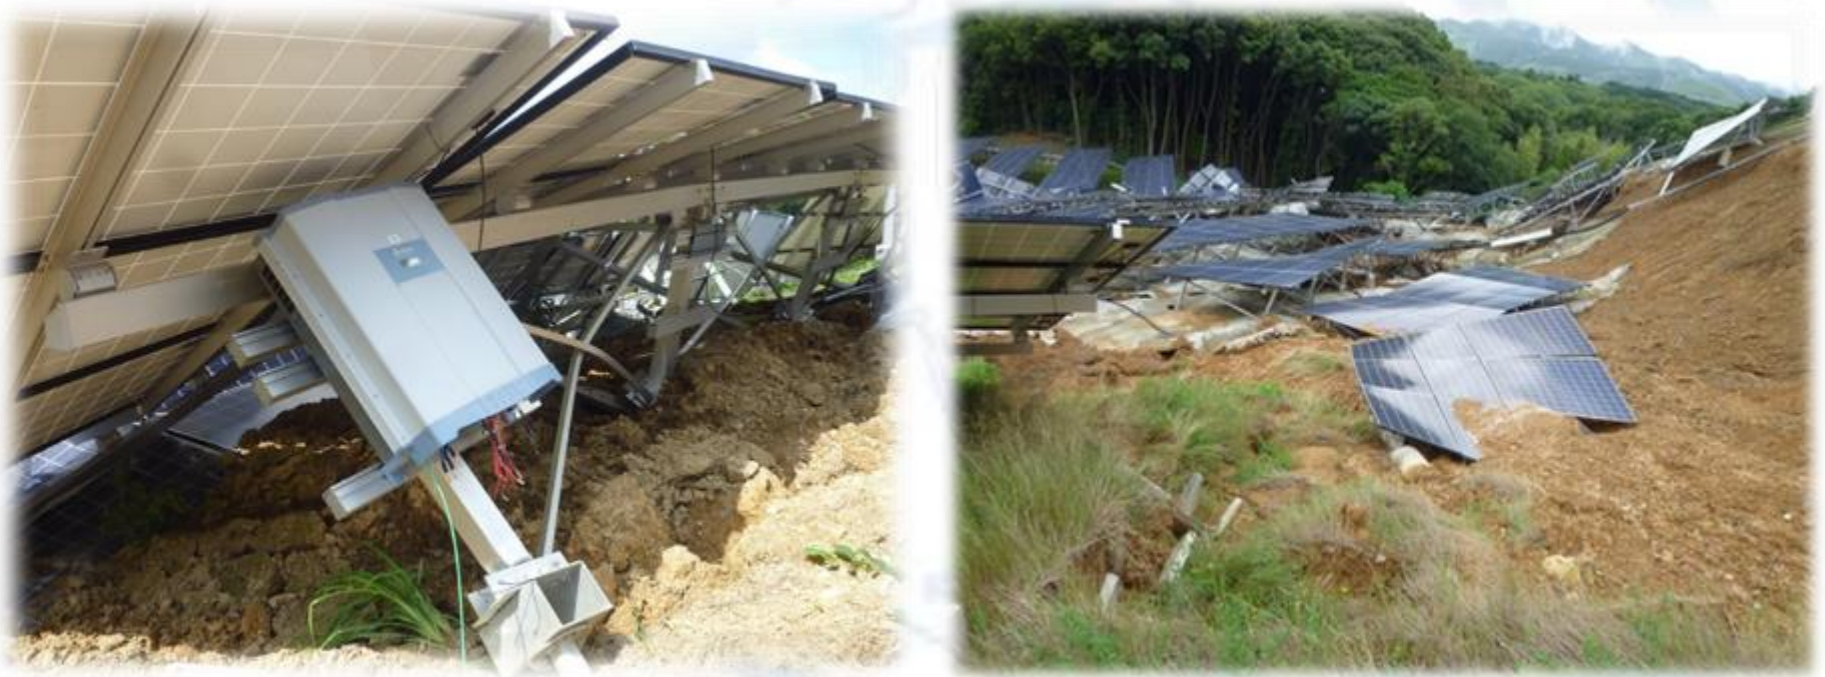
Landslide damage due to heavy rain

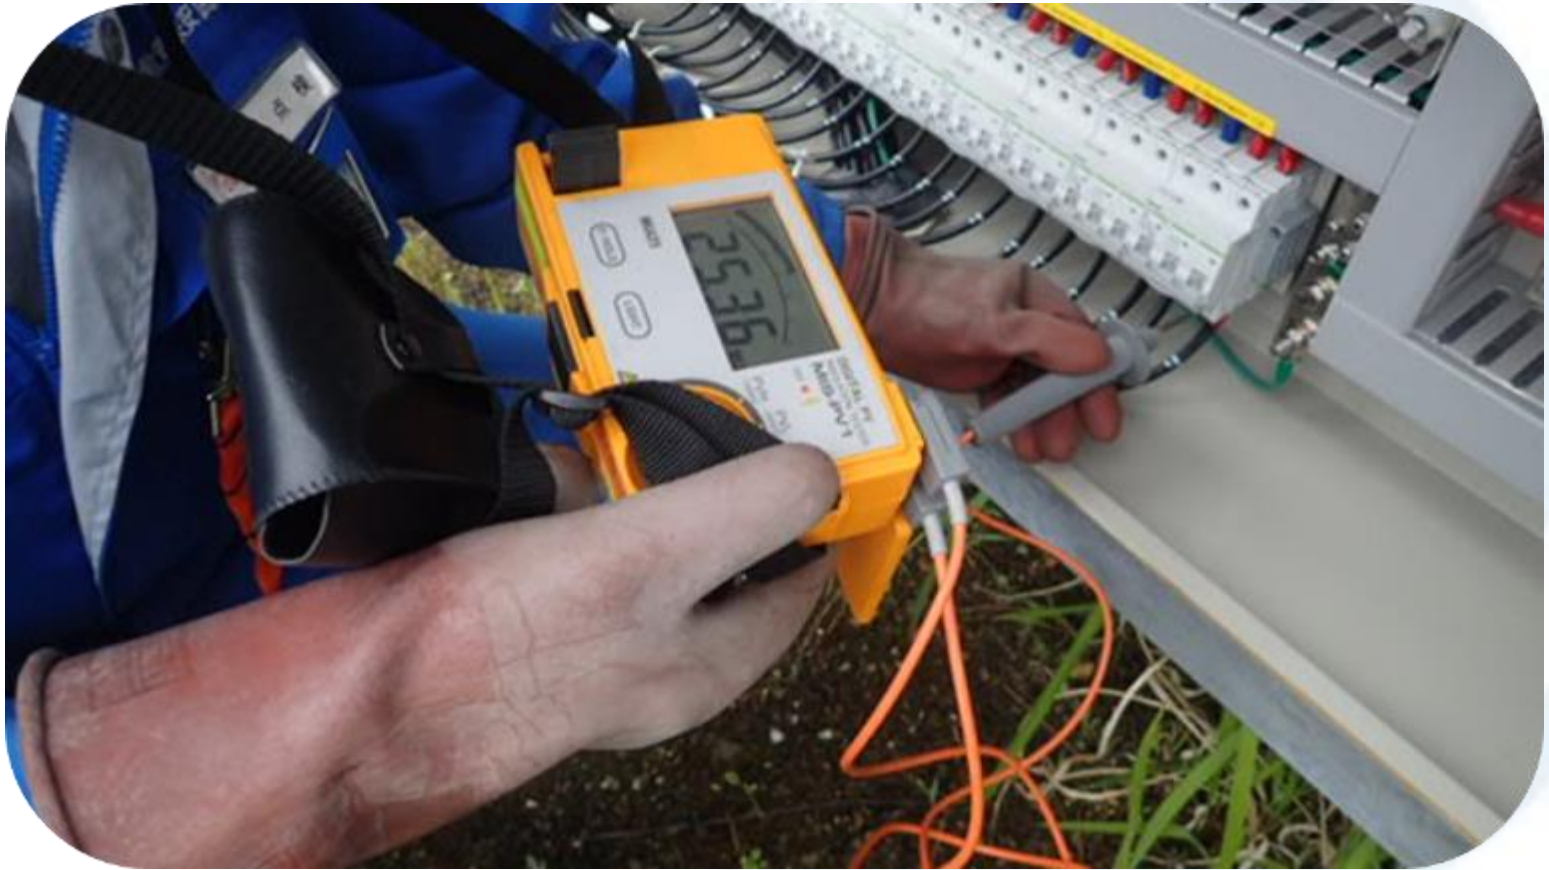
## Example of efficiency improvement 1: Better insulation resistance measuring efficiency — Before

Measurements were taken while checking information displayed on a screen.

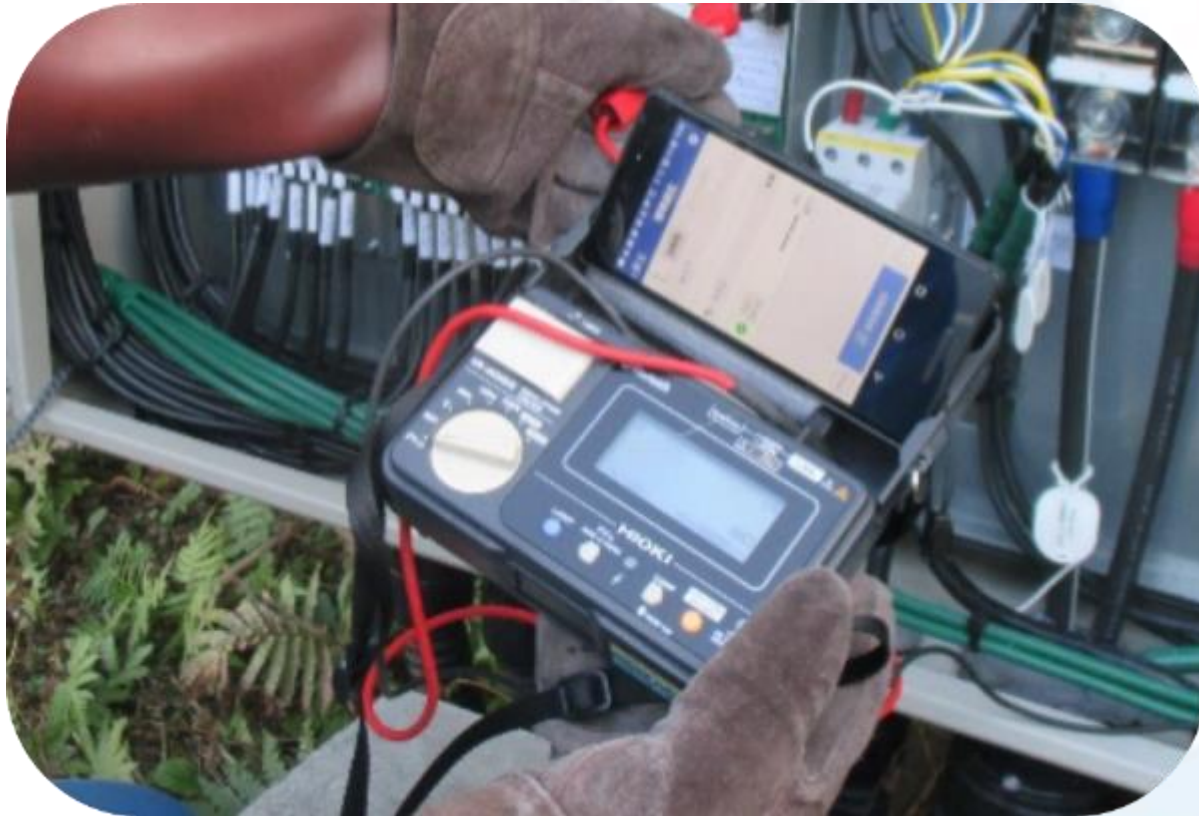
## Example of efficiency improvement 1: Improvements made to insulation resistance measuring efficiency — After Streamlined report generation

Data saved on smartphone

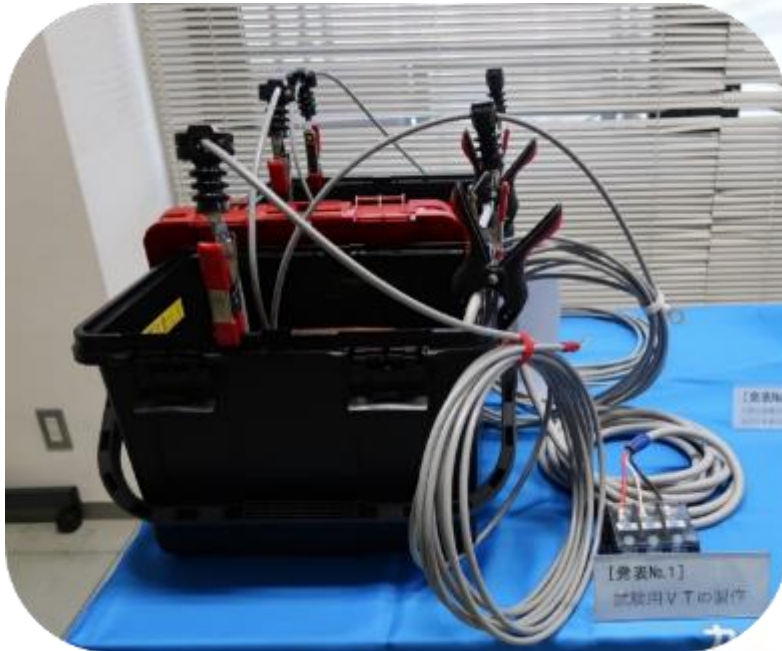
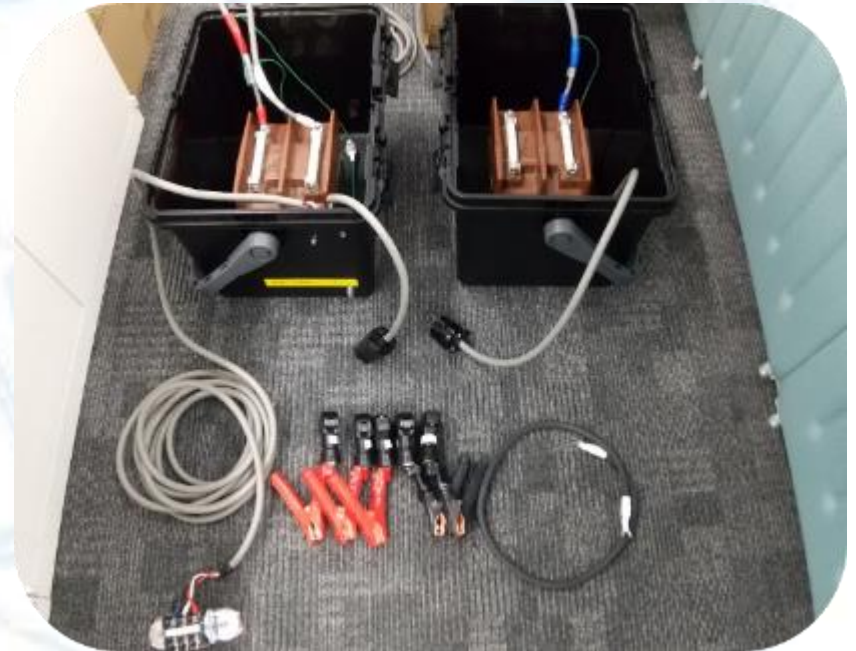
## Example of efficiency improvement 2: Better load rejection testing efficiency

Better workability thanks to reduced weight

VT fabricated for testing

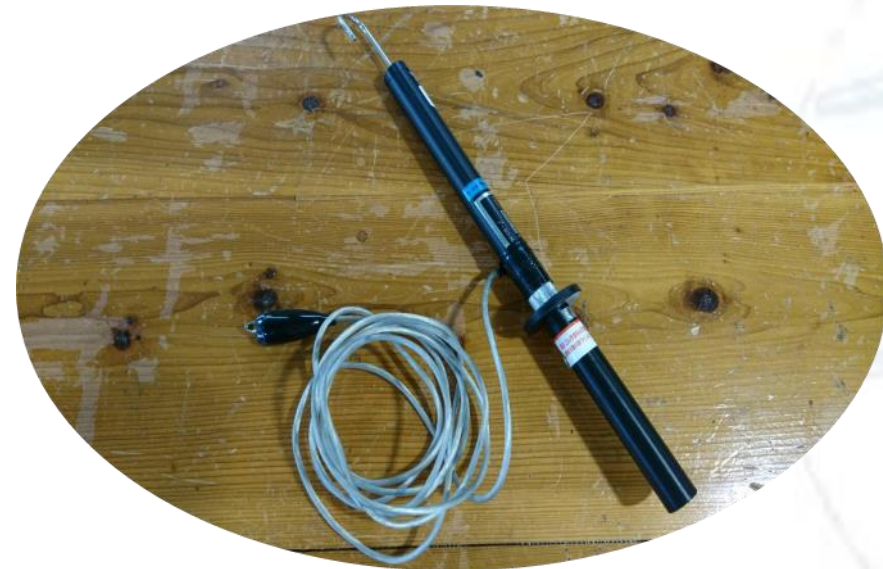
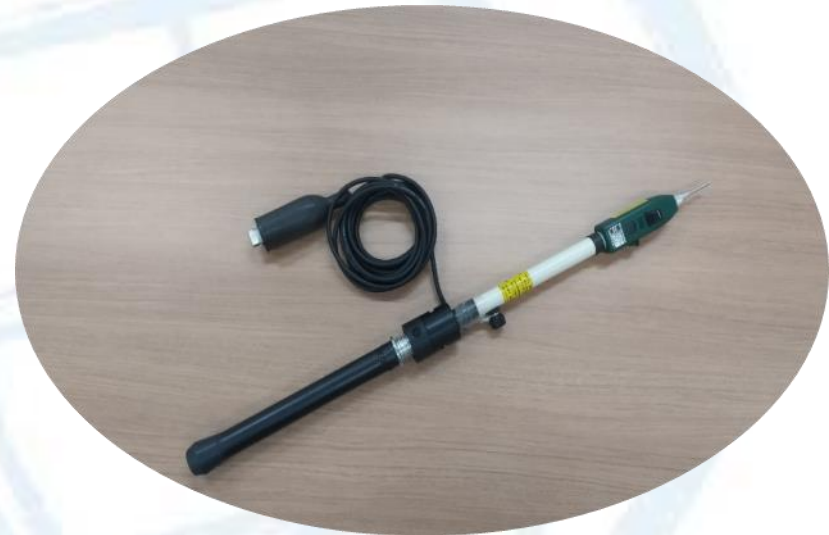
### Example of efficiency improvement 3: Better dielectric strength testing efficiency

After testing the PV facility on site, charges are discharged to ensure safety.

- Unable to determine if discharge was complete

- Residual charge is indicated by sound and light

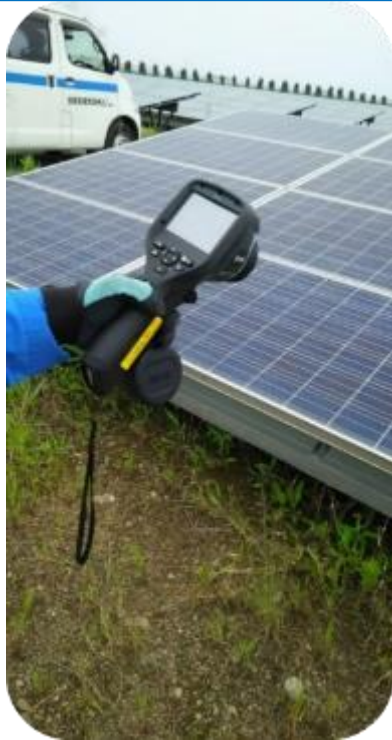
Inspection performed using  
thermal imaging camera

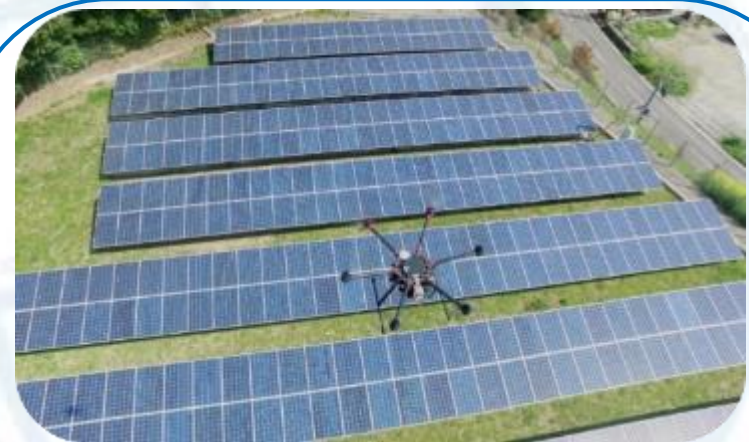
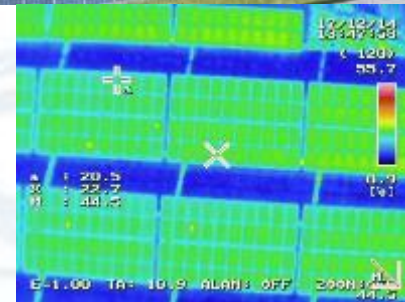
Perform large area inspections efficiently from the air

Filmed by drone

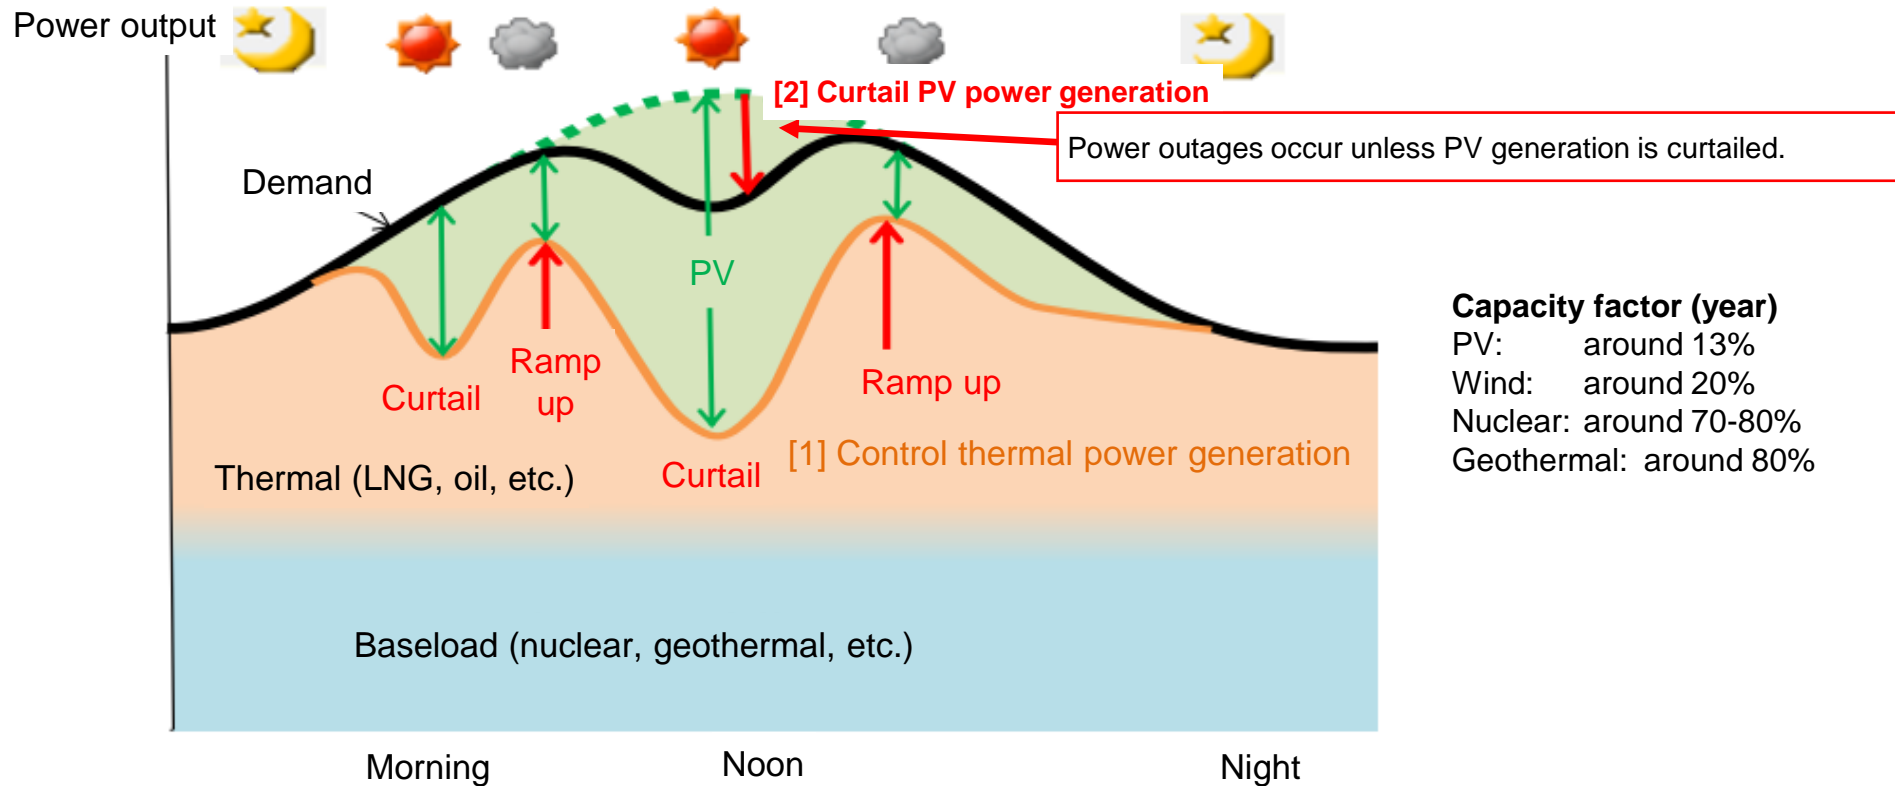
At times of low demand, PV power plants need to be shut down.

[Illustration of supply-demand on minimum demand days (sunny days in May, etc.)]

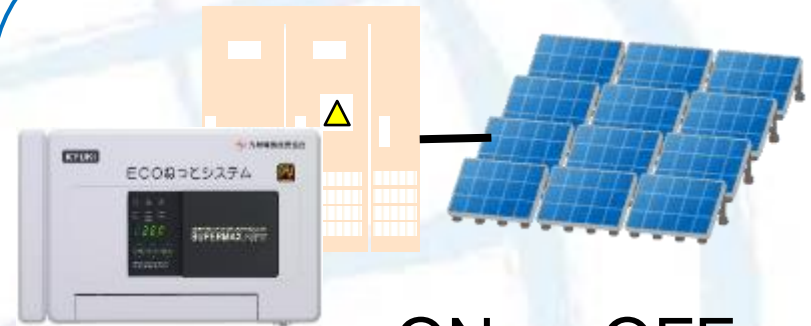
Manual work reduced with the introduction of remote system

ON ⇔ OFF

Make timer settings on  
remote system

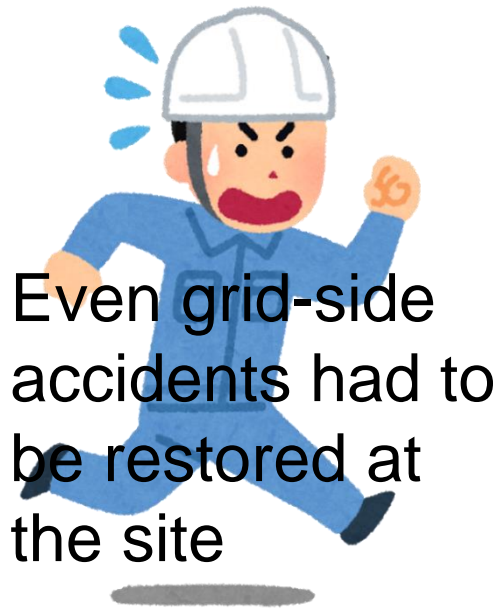
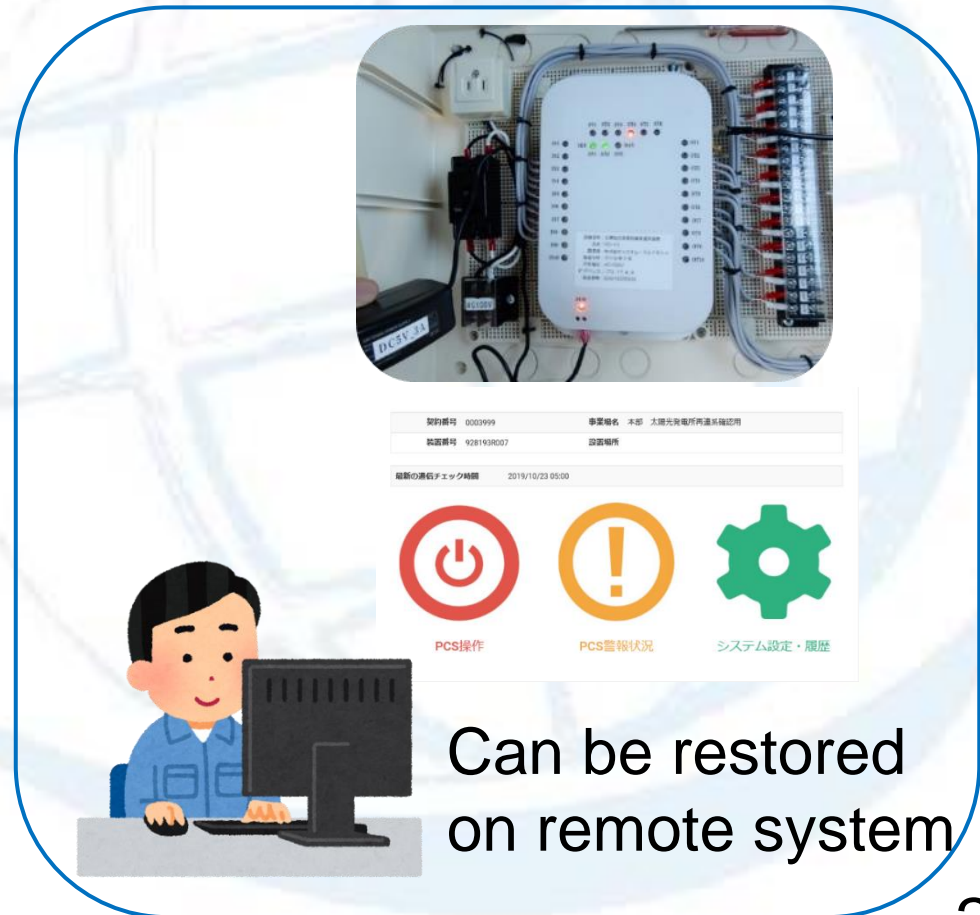
Example of efficiency improvement 6: Better efficiency in recovering from grid-side accidents

Less time spent traveling to and from sites

Can be restored on remote system

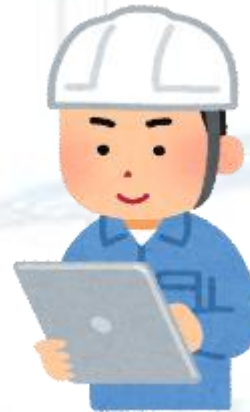
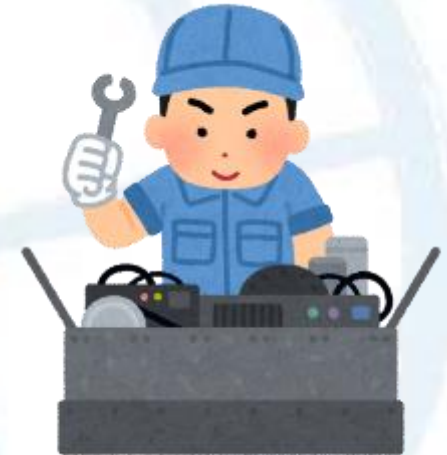
### Utilize AI and IoT

Constant monitoring system  
Improvements to testing and  
measuring equipment
